# Generating Bank Casing-to-Sidewall Tube Welds on Two-Drum Boilers

Technical Service Bulletin

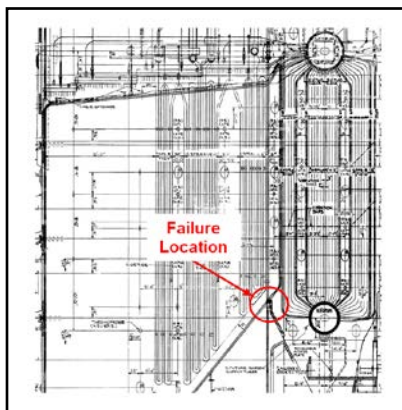
A problem has been detected on two-drum Babcock & Wilcox (B&W) recovery boilers where the generating bank hopper and sidewall casing attach to the furnace sidewall membrane wall tubes. Units that have a history of severe generating bank pluggage are believed to be more susceptible. Because the damage may initiate by stress-assisted corrosion cracks at the inside diameter (ID) of the tube, early detection requires nondestructive examination of the second sidewall tube in the vicinity of the generating bank sidewall casing attachment. See Figure 1.

Figure 1 – Failure location

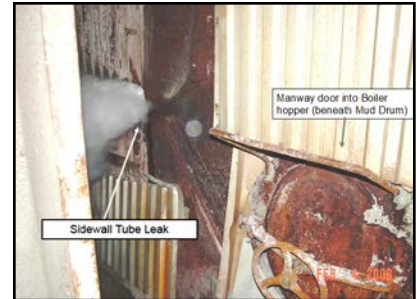
One incident reported was a catastrophic tube failure of the furnace sidewall tube adjacent to the generating bank hopper sidewall. The failure is believed to have been caused by stress-assisted corrosion fatigue from frequent temperature transients of the generating bank casing. Experience suggests that this mechanism could be aggravated by certain weld attachments and/or water chemistry. Because the buckstay and tie channel system is integral with the generating bank casing, any boiler ties between the buckstays or drums and the building structural steel near this area may cause additional distortion at the failure location. See Figures 2 and 3.

Figure 2 – Tube leak

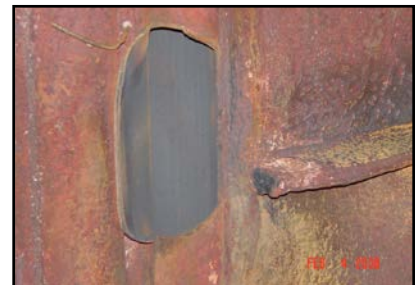
Severe generating bank pluggage causes increased pressure drop which leads to gas bypassing underneath the lower drum through and around the hopper gas baffle. This causes the generating bank hopper and sidewall casing to experience large temperature transients. The frequent temperature transients cause thermal stresses in the hopper sidewall casing which can lead to a fatigue failure

Figure 3 – Tube failure

in the casing attachment at the sidewall tube.

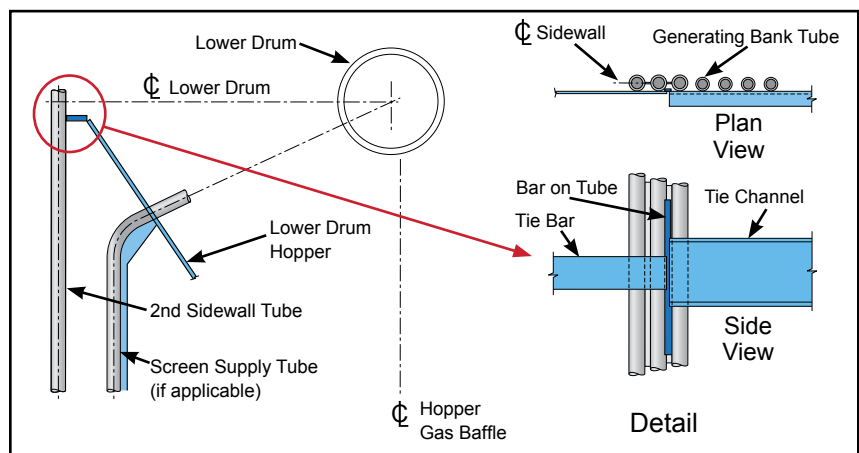
Figure 4 – Attachment

The attachment is shown in Figure 4. The failure was at the approximate location defined by the red circled area in Figure 4, near where the membrane wall panel tie bar meets the generating bank tie channel at about the centerline of the lower drum elevation.

2. Inspect adjacent tube and casing attachment welds for cracking, and repair as needed. Review all boiler ties to building structural steel near the generating bank and drums to assure they are installed correctly and are not damaged.
3. If the attachment is replaced and/or the tube section is removed, utilize an upgraded attachment as shown in Figure 7. This arrangement better distributes the casing load across the first and second sidewall tubes at the generating bank sidewall.

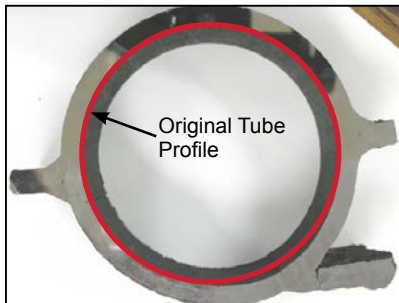
Plant owners and operators should inspect the lower drum hopper baffle plate for evidence of distortion or gaps which can allow gas bypassing. If a history of generating bank pluggage with high pressure drop, and casing or hopper repairs and/or signs of gas bypassing is present, then inspect the sidewall tube-to-casing welds as soon as possible. The damage to the tube may originate in cracks at the tube ID, so radiographic inspection of the tube in the area of the casing attachment is required for early detection. See Figures 5 and 6.

Figure 5 – Failed tube cross-section showing tube distortion and attachment damage

1. If evidence of gas bypassing is present, take whatever actions are needed, including additional sootblowing in the generating bank to reduce plugging, and repair the lower drum hopper baffle to prevent excessive bypassing.

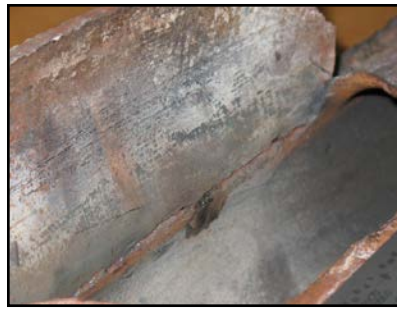
Figure 6 – Tube failure
