## Purpose

This bulletin advises owners and operators of UP boilers to inspect for cracks in tube panel membranes and tubes located near the junction between boiler sidewalls and the pendant superheater floor.

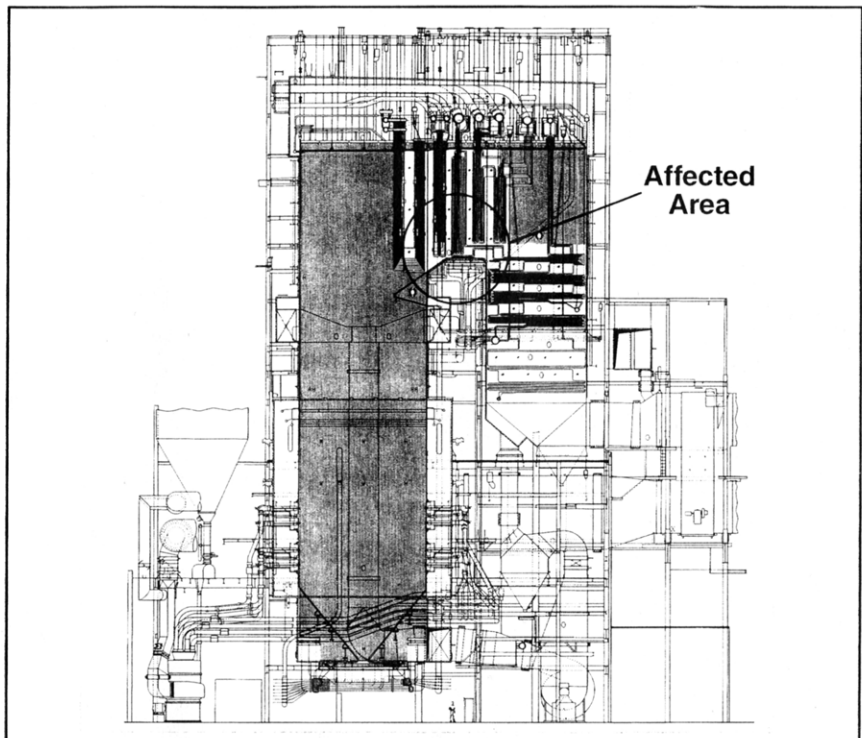
Cracking has been found in the floor membrane near the boiler sidewalls. Figure 1 shows the general area where cracking has occurred. The construction of the floor-to-wall connection at the floor tube bends is relatively stiff. Therefore, the locations between the sidewall tubes and the superheater floor are the most prone to membrane cracking (shown in Figure 2). During rapid unit start-up and shutdown (see PSB-20), the thermal gradients generate sufficient stresses to form cracks in the floor membrane near the sidewalls, and high stresses in the side wall tubes. These cracks can propagate into the tube wall, resulting in leaks.

Figure 1 Area affected by superheater floor tube cracking and failures.

Closely examine the floor tubes and membrane near the floor-to-wall junction for cracks. If membrane cracking is found, repair or replace the membrane. If cracking has propagated into the tube metal, replace the affected tube(s). The floor tube membrane should be slotted at the location shown on Figure 3 for a distance of approximately four feet centered on the tube bend (see Figure 2, Locations 1 and 2). All slots should start and

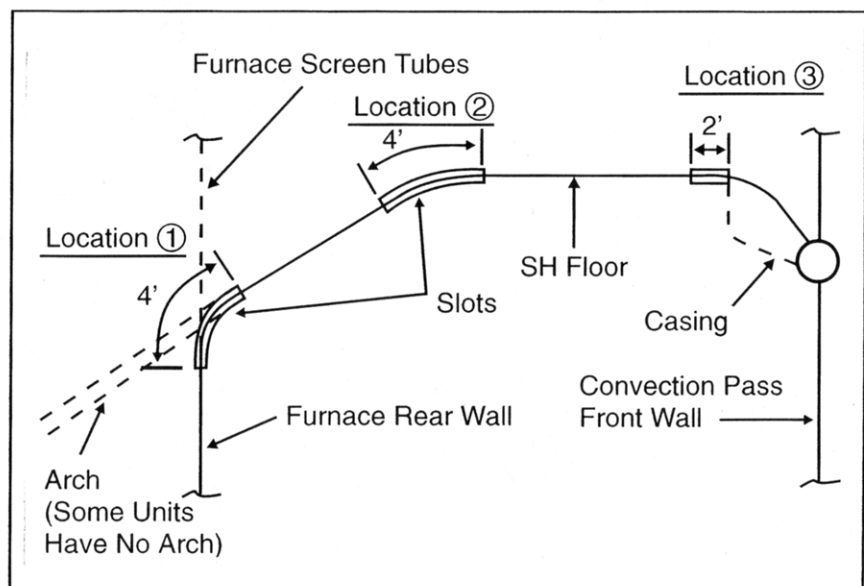
Figure 2 Stiff construction locations are prone to membrane cracking.

stop in 1/4" diameter drilled holes. At Location 3 in Figure 2, the membrane should only be slotted toward the furnace from the bend, since the floor is not attached to the sidewalls in the cased areas near the convection pass intermediate header. In accordance with Figure 3, install a gas-tight seal over the slots using 10- or 12-gauge carbon steel plate and filler bars. This modification increases the flexibility of the connection at the tube bends. It also provides more flexibility between the superheater floor and pendant side walls, which lowers the stress when temperature gradients occur during startups and shutdowns.

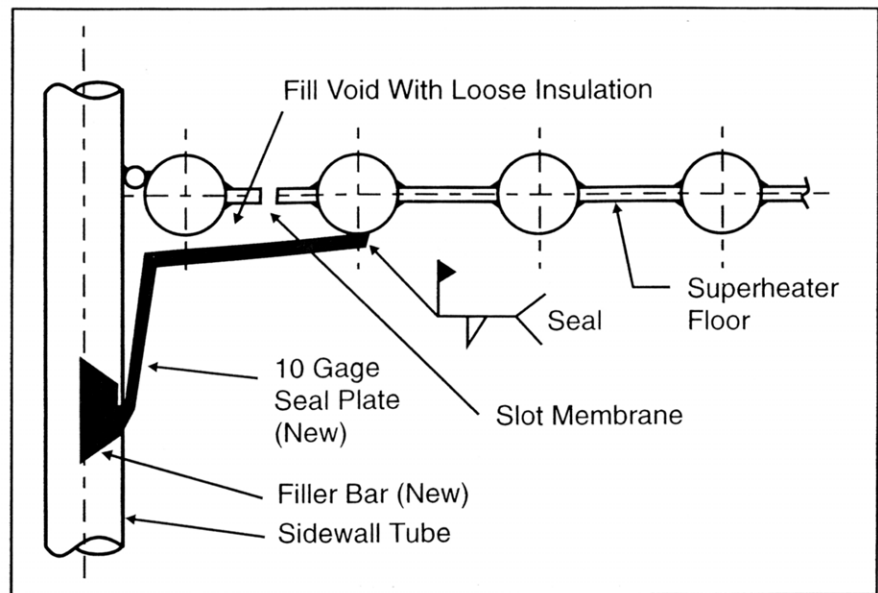
**Figure 3** Installation of a gas-tight seal over the slots increases the flexibility of the connection.
